Health Impact Assessment (HIA) of Development Projects with Reference to Mosquito-borne Diseases

HIA Studies undertaken by NIMR

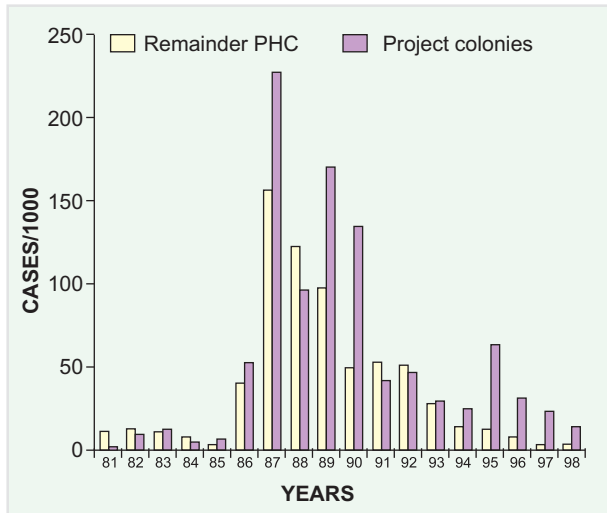
Fig. 106: Secular trend of malaria in project colonies and the surrounding PHC villages (Sardar Sarovar Dam)

An unusual increase in malaria was recorded at

the project site following commencement of the construction of the dam (Fig. 106). An epidemiological investigation undertaken by NIMR during 1994–98 showed that *An. culicifacies* and *An. fluviatilis* were present in the colonies at the project site and in the surrounding villages. *An. culicifacies* was the predominant species. Although the dam has been built in the valley area, creation of dyke ponds and interruption of downstream flow of water caused potential breeding habitats of vector species resulting in a built up of high vector densities. The incidence and prevalence rates of malaria were far higher in the population at the project site as compared to those in the surrounding villages (Fig. 107). The increased transmission of malaria at the project site was attributed to the factor such as the congregation of migrant work force from the malaria endemic areas of the country in close proximity of the mosquito breeding habitats created by the project.

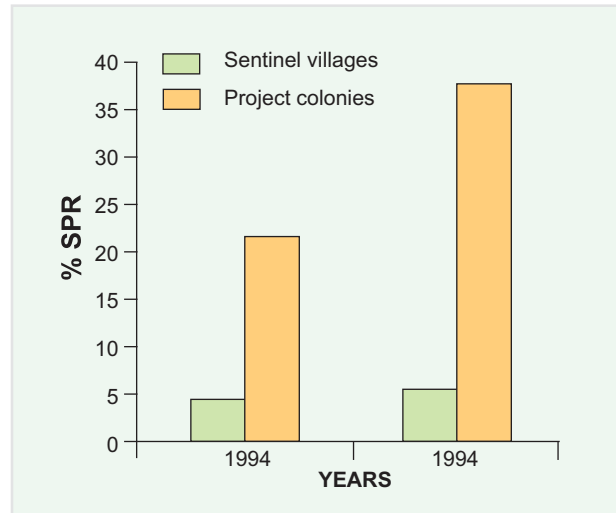
Fig. 107: Malaria incidence in the project colonies and the surrounding villages (Sardar Sarovar Dam)

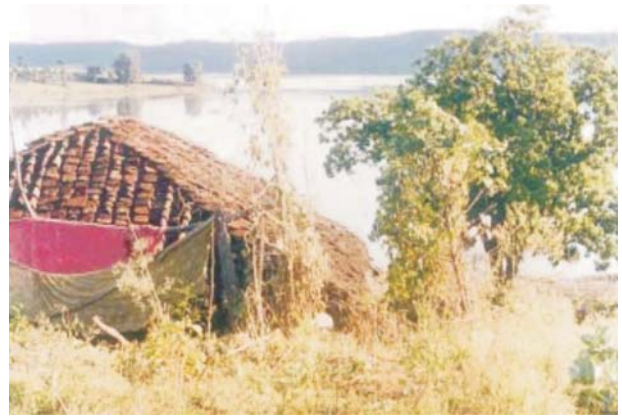
Fig. 108: Photograph showing hutment in Bargi Dam area

Some of the risk factors identified are: widely distributed clusters of hamlets, increasing operational difficulties in disease surveillance, continuance of the people in some submerged villages, increased groundwater level, fishermen's preference to live close to the reservoir (Fig. 108), migrant fishermen and lack of commensurate increase in medical care and insecticide spraying. Effective prevention and control of malaria in affected villages should include improved disease surveillance, use of effective antimalarial drugs, use of rapid diagnostic kits in epidemic situations, health education, use of effective insecticides, promotion of the use of insecticide impregnated nets. Displaced people should be resettled in healthy areas. Poor engineering design is difficult to correct after

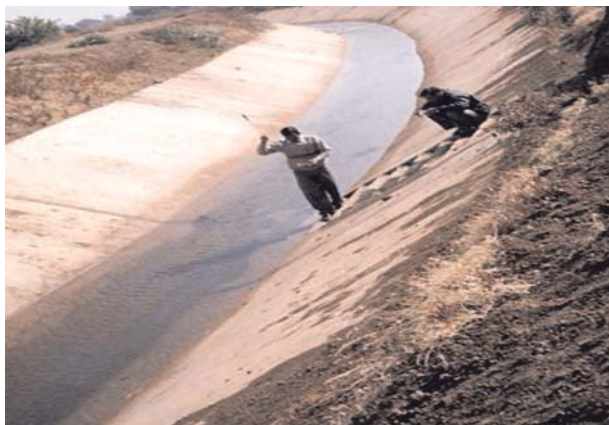
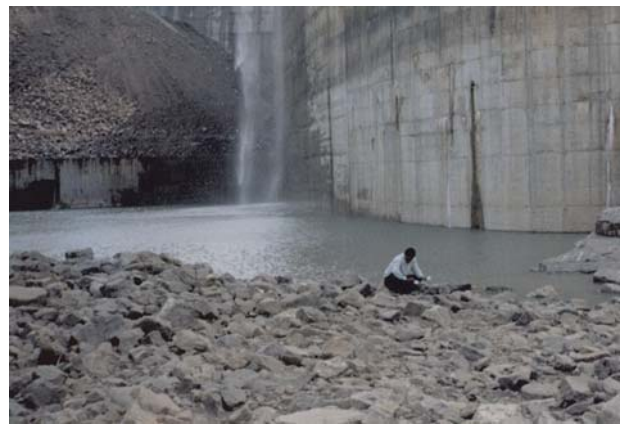
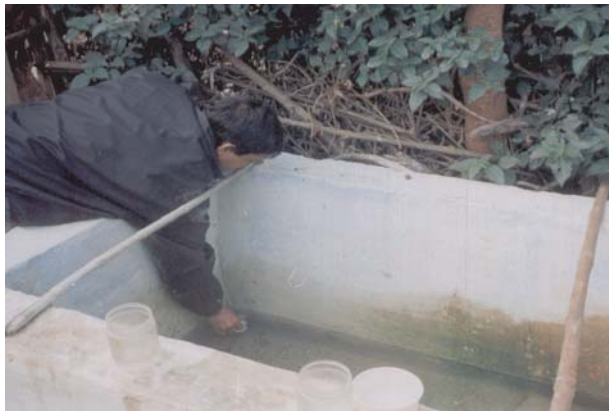
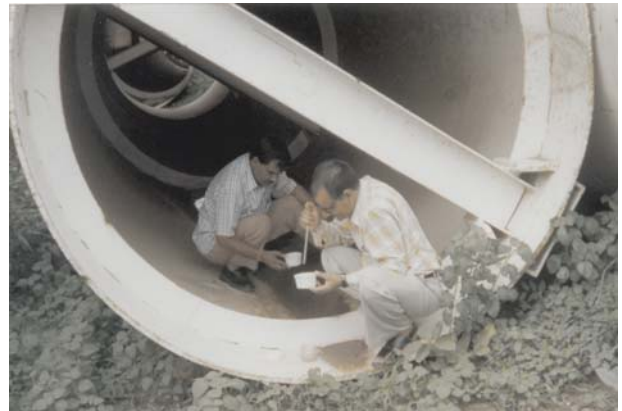
Fig. 109: Mosquito breeding habitats found near the dam site

Till April 2008, 13 surveys in different seasons were carried out in seven districts, viz. Khandwa and Dewas (ISP & OSP), Khargone and Harda (ISP), Badwani, Dhar and Jhabua (SSP). Mosquitogenic conditions created due to dam construction, viz. seepage of the reservoir, pits and pools of down streams, new canals created, curing tanks etc. (Fig. 109) have been identified. Surrounding to these, a total of 32 villages, 18 rehabilitation and resettlement centres and five command area villages and six labour colonies under seven districts have been surveyed for entomological and epidemiological data for all the vector borne diseases, i.e. malaria, dengue, JE and filariasis.

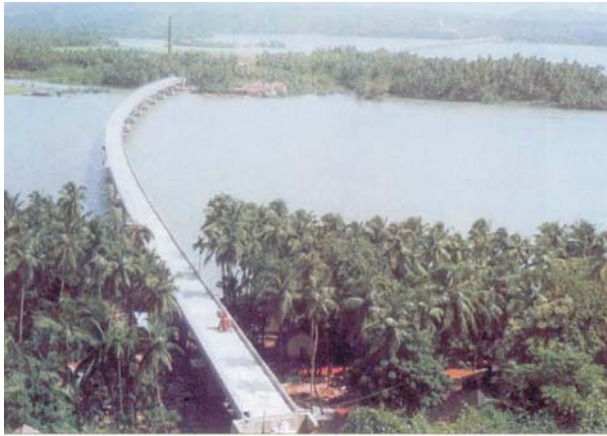
Fig. 114: To lay railway line long bridges had to be constructed over the broad perennial rivers

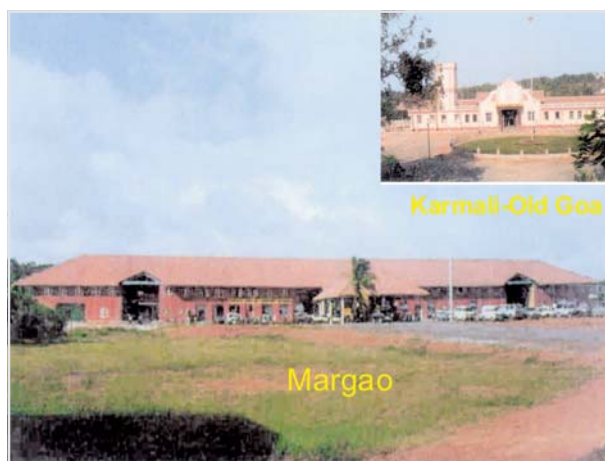
Fig. 115: Konkkan Railways Station at Margao and Karmali-Old Goa (Inset). With the timely intervention of NIMR, the design of station building was changed by the Konkkan Railway Corporation and sloping roofs were provided to prevent water stagnations on station terrace during heavy monsoons experienced in the Konkkan Region

1. Sloping roof of station and residential quarters (Fig. 115).
2. Installation of mosquito proof over head tanks at station buildings and residential quarters.
3. Construction of septic tanks and soak pits at staff

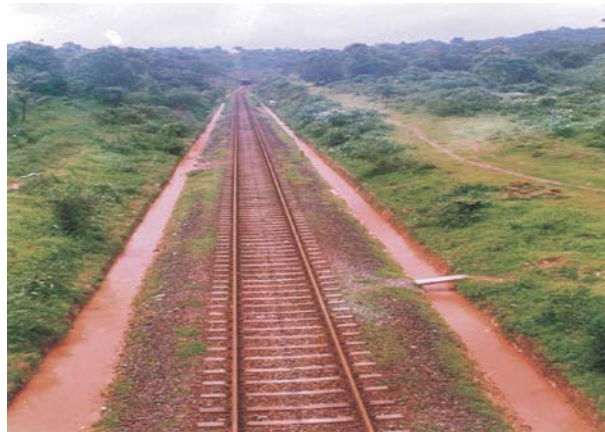
Fig. 116: Pacca drains were provided all along the track in the cutting section for efficient flow of water

Fig. 117: All abandoned masonry tanks were filled with soil to prevent water collection and mosquito breeding

- quarters and railway stations.
4. Clearance of drains near the cutting section near the mouth of tunnels and providing concrete drains along the track (Fig. 116).

5. Efficient drainage of water at the railway station and coach washing yards.
6. Filling or demolition of tanks after construction of major and minor bridges tunnels, etc (Fig.117).

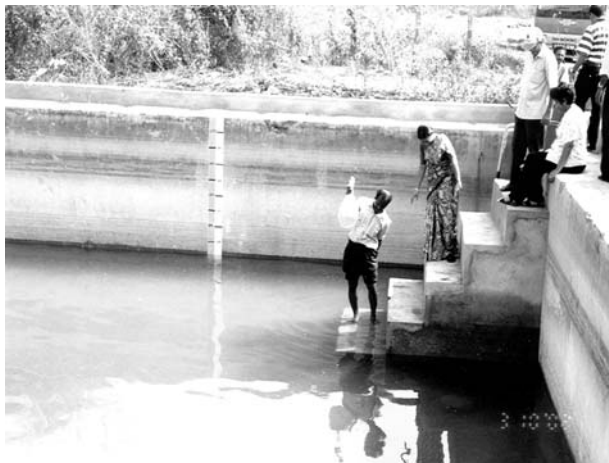
Fig. 118: Abandoned sleeper curing tanks were stocked with larvivorous fish *Poecilia reticulata* and handed over to the Directorate of Health Services Goa for fish propagation and distribution

Fig. 119: Konkan Railway Engineers and Scientists of NIMR inspecting Railway Quarters site under construction where water stagnation was supporting anopheline breeding

9. All abandoned sleeper curing tanks were either filled and leveled or repaired and converted to larvivorous fish hatcheries (Fig. 118). A system of fish supply to establish hatcheries at the Primary Health Centre's was made operational.

10. Removal/drying up of water stagnations during construction of railway quarters (Fig. 119).
11. Re-usable fibre glass plastic food trays/cups and waste collection system were introduced in the trains.
